AGRICULTURAL IMPACTS

Resulting From Wind Farm Construction

October 2005

NYS Department of Agriculture & Markets

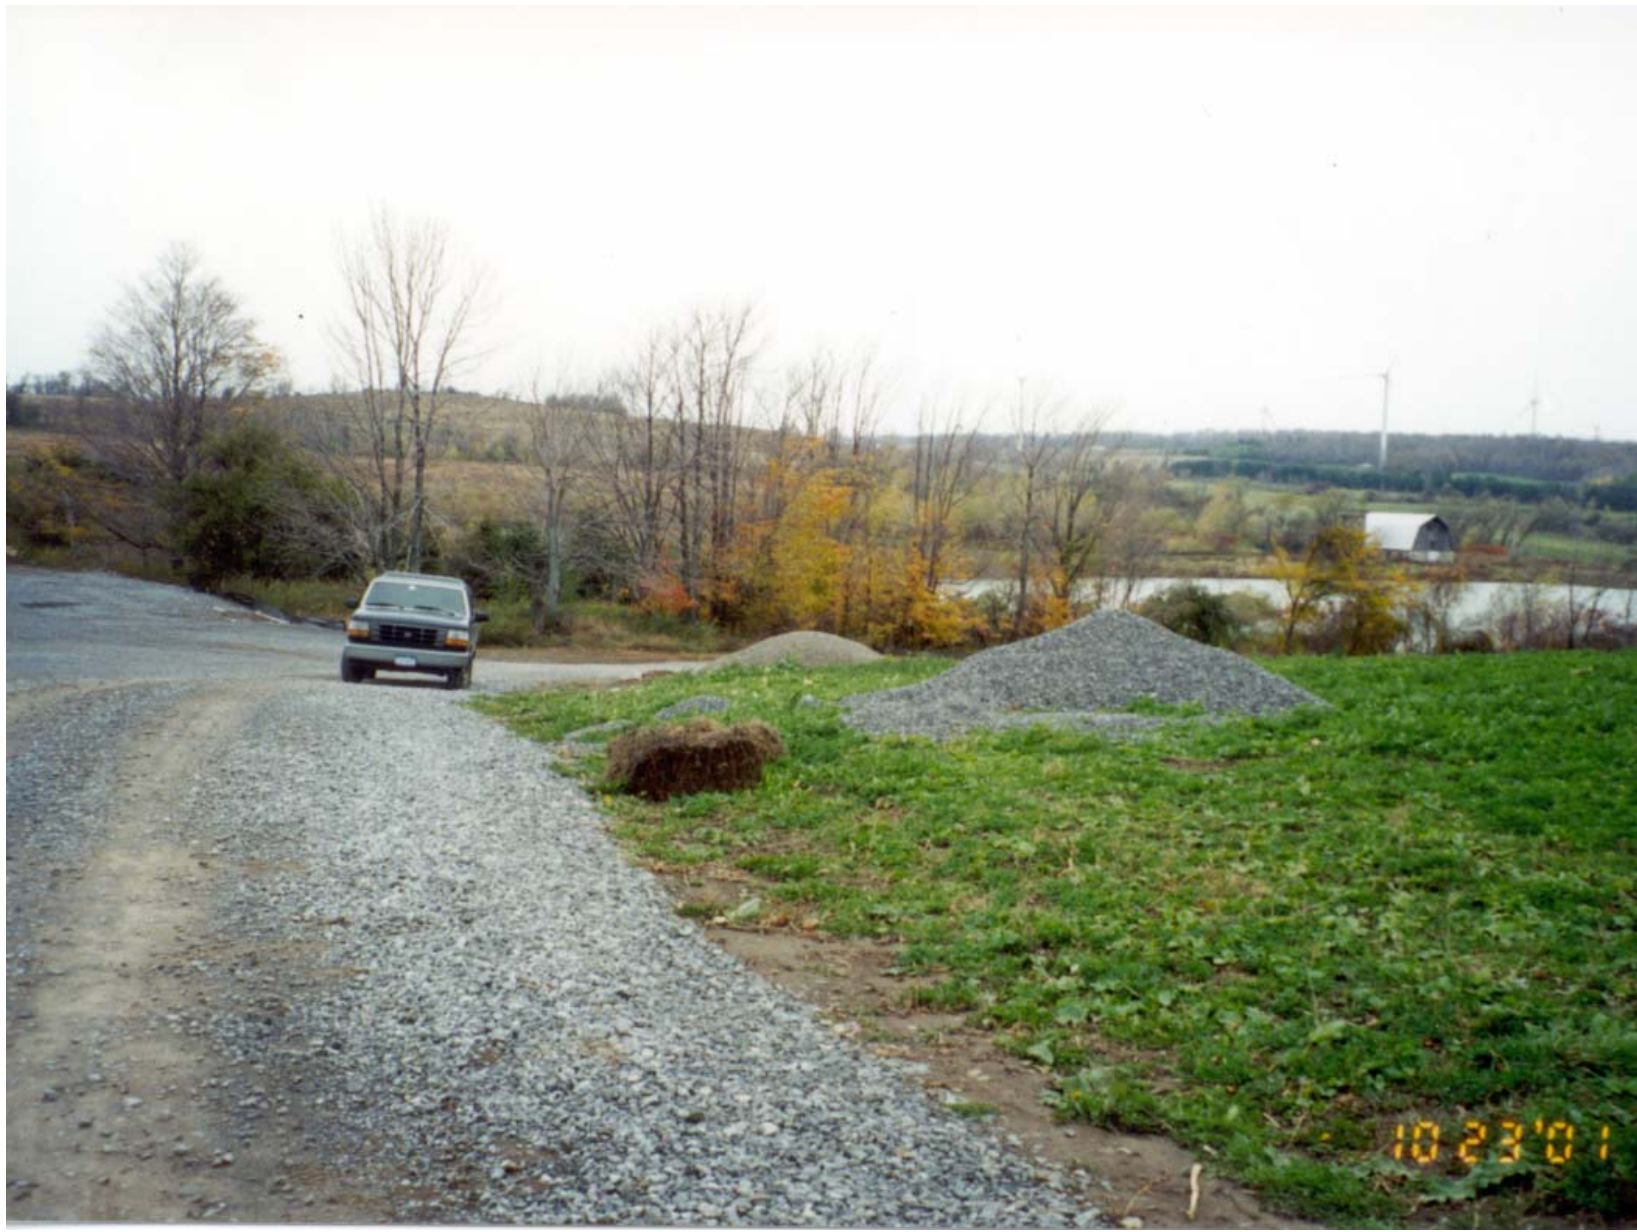
Crushed stone should not have been dumped in the agricultural field. Some stone was left in the field after restoration causing damage to the alfalfa stand.

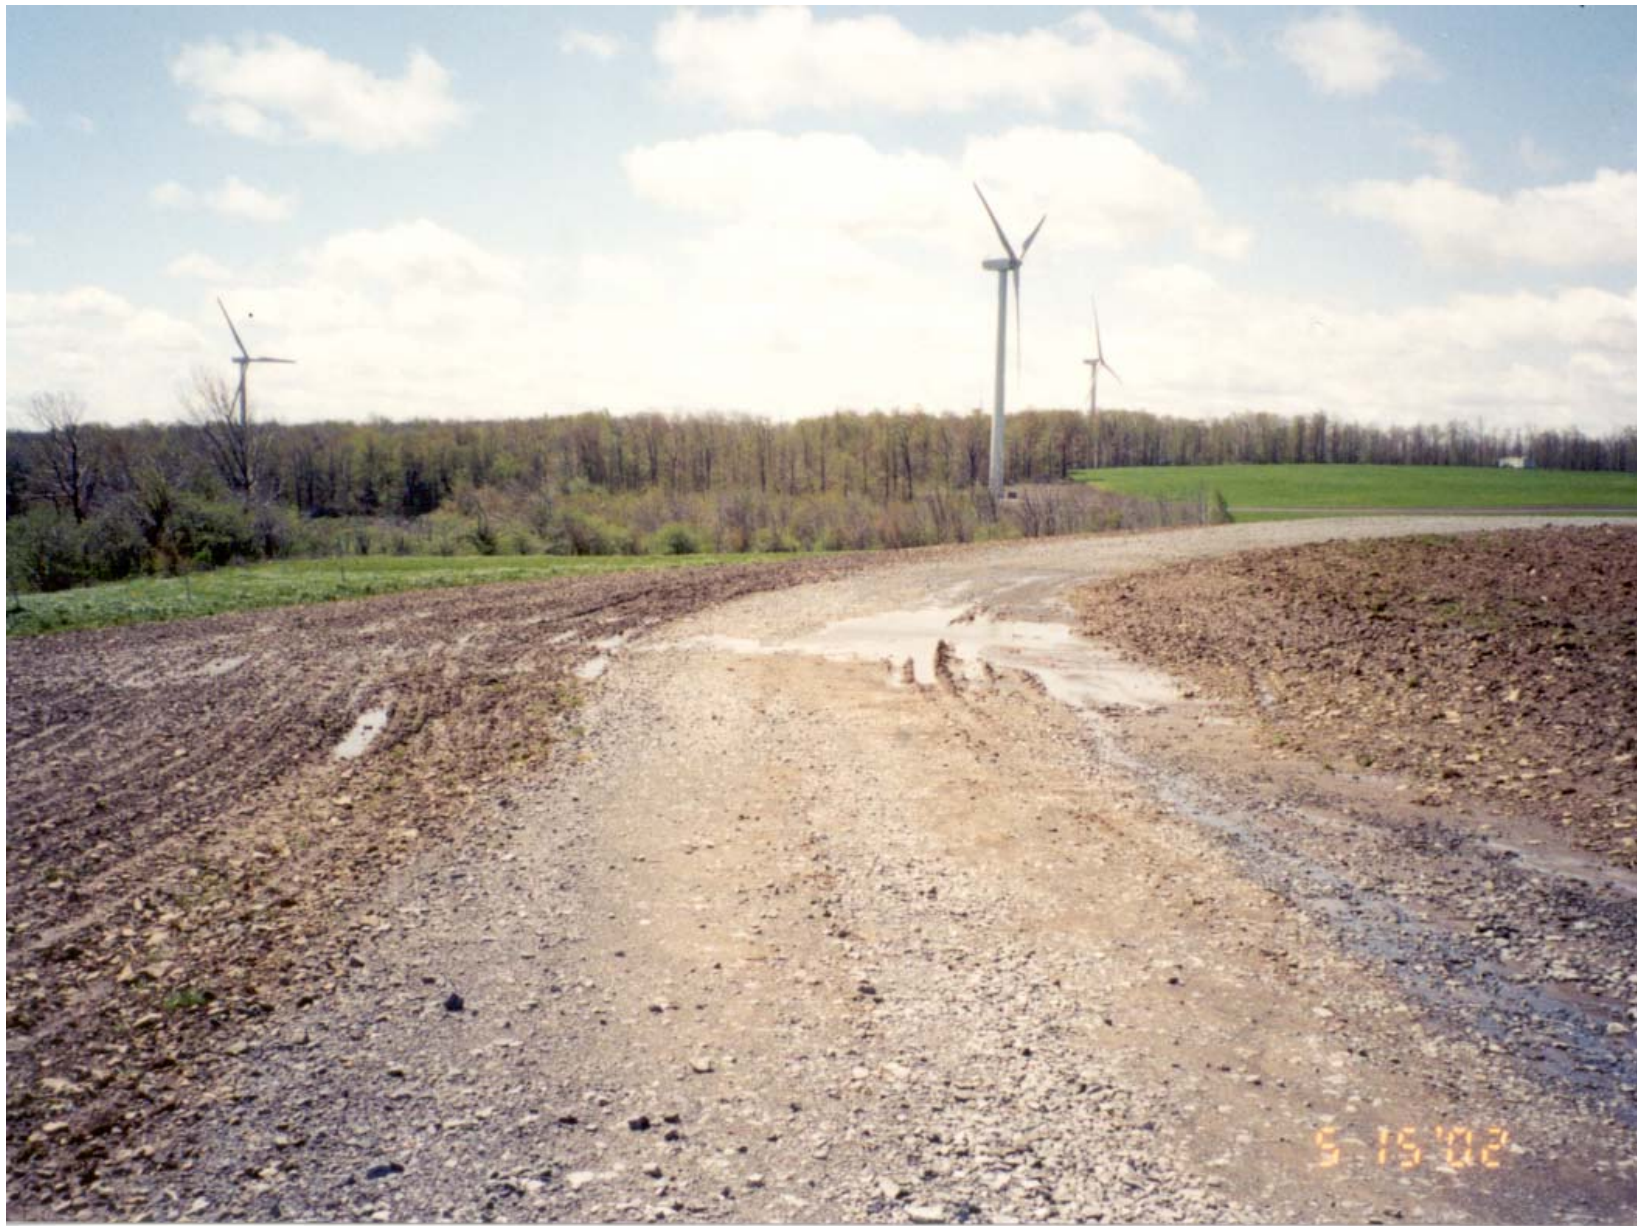
This slide shows the soil saturation problem caused in the field on the left side of the access road. These types of drainage problems must be corrected to prevent damage to the fields.
